Resilient Landscapes and Livelihoods Project

Bamboo development for rehabilitation of degraded land

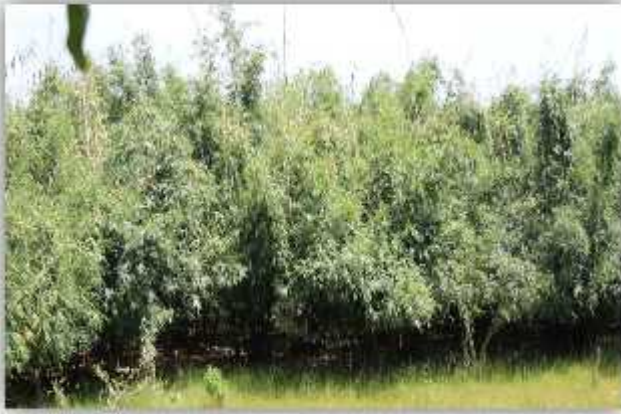
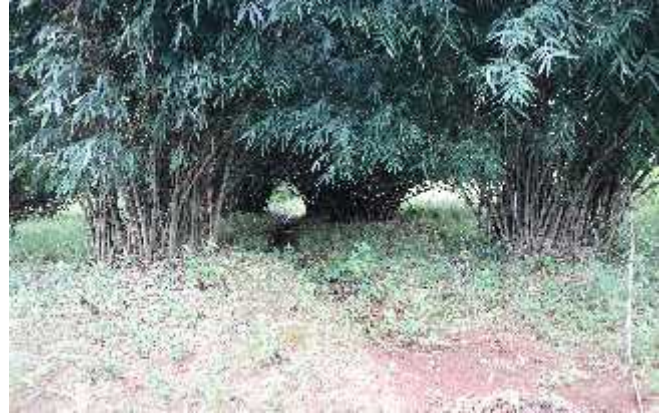
In the micro watershed, more than 165 ha of degraded communal land has treated with physical soil and water conservation measures like Fanayajoos and trenches. Finally, the physical measures supported by biological measures like grass planting and bamboo tree planting on terrace. The planted materials stabilized the soil embankment and covered the bare ground. Due to this coverage, soil erosion had reduced dramatically. The matured bamboo forest area also served as habitat for wild animals and maintained the ecosystem. This woody plant (bamboo) has been use for communities living in the watershed as a raw material for traditionally building and it has used for making numerous household utensils, basketry, and handicrafts, and the foliage has used as animal fodder source.
